GPS Receiver conversion

Technical Procedure

Document No. PRC-GPS-0001

Issue C, May 2019

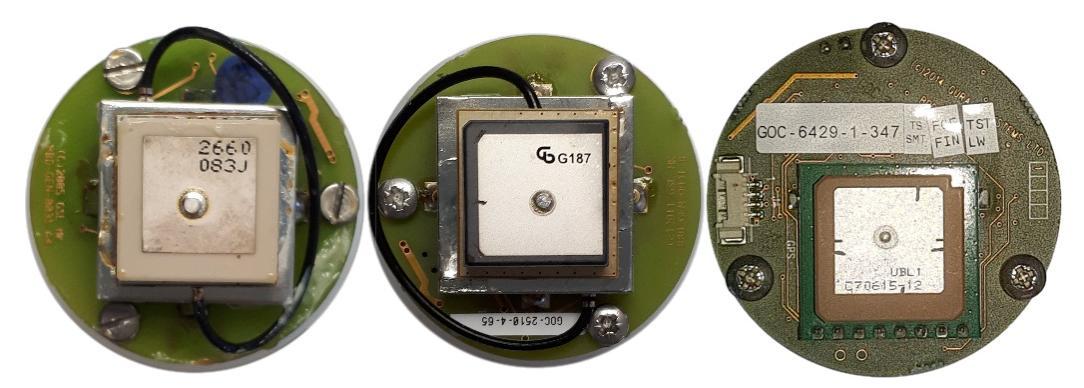
2. Check that the PCB assembly contains either a Trimble Lassen SQ[®], or Trimble Lassen iQ[®] by comparing it with the images below:

The three receivers shown contain, from left to right,

- 1. Trimble Lassen SQ® (cream/ceramic-coloured module with silver top)
- 2. Trimble Lassen iQ® (black module with silver top)
- 3. u-blox PAM 7Q (brown module with silver top)

Note: Only proceed if you have one of the two Trimble Lassen[®]based PCBs. If you have a receiver based on the u-blox chip-set, as shown on the right above, you will not be affected by the WRNO and you do not need to replace the PCB assembly.

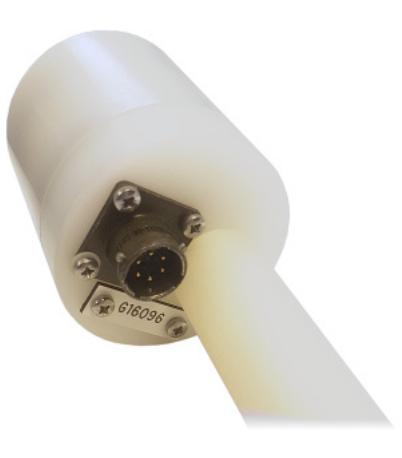
The serial number of the receiver is engraved on a white plate screwed to the base of the receiver.

If your serial number begins G3..., it has a u-blox chipset and does not need to be upgraded.

If your serial number begins G1... or G2..., it may have a Trimble chip-set (either iQ or SQ) and may need to be replaced. Another identification technique is required to distinguish in this case.

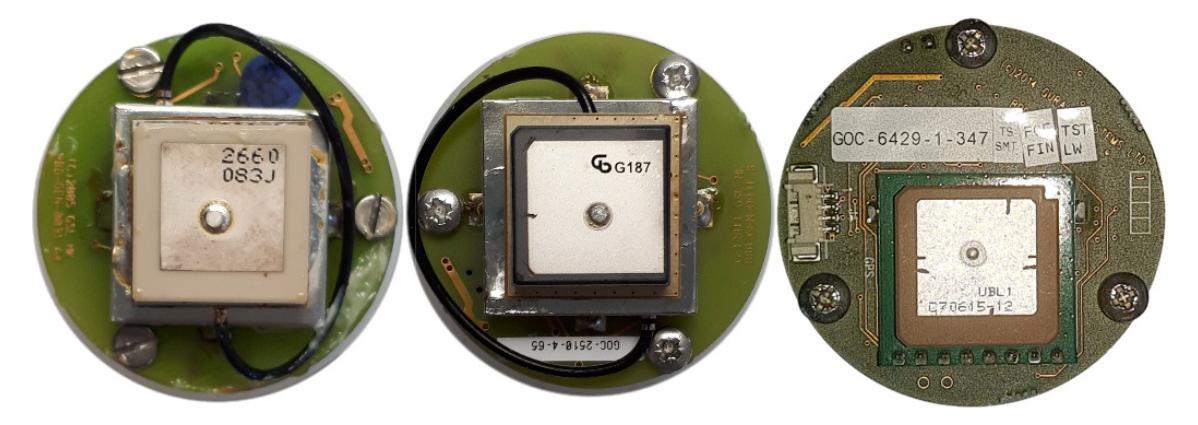
Compare your unit to the photographs below, paying particular attention to the antenna, which is the uppermost component and is identified by its silver top:

- Left: Lassen SQ chip-set. The antenna has a cream-coloured casing
- Centre: Lassen iQ chip-set. The antenna has a black casing
- Right: u-blox chip-set. The antenna has a brown casing
